UNITED STATES DISTRICT COURT  
WESTERN DISTRICT OF NEW YORK

Civil No.: 18-CV-00402

**AFFIDAVIT OF JENNIFER L. YAEK, PH.D., P.E.**

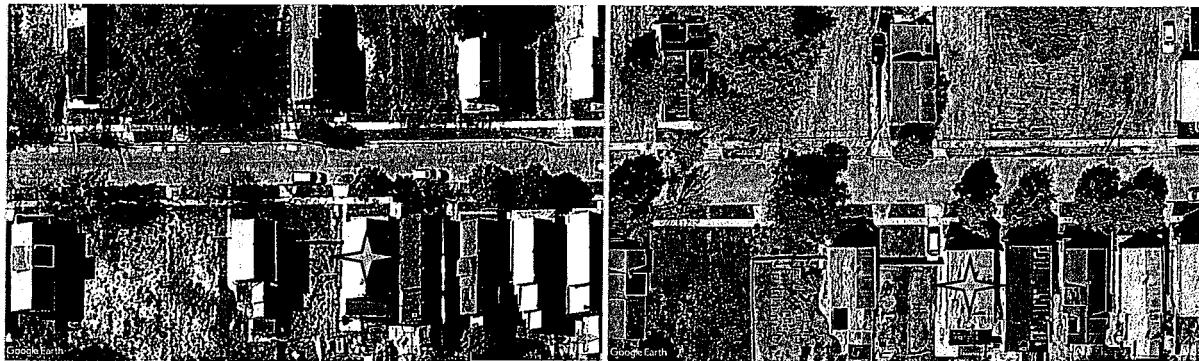
Aerial images were obtained from Google Earth Pro of the subject incident location encompassing dates from October 5, 2011, to May 29, 2017, to show there has been no significant geometrical changes to the roadway or surrounding driveways, sidewalks, or houses over the years (Figure 1).

Figure 1: Google Earth Pro Images of 37 Schmarbeck Road: (left) taken October 5, 2011, (right) taken May 29, 2017 (Star designates 37 Schmarbeck Road residence)

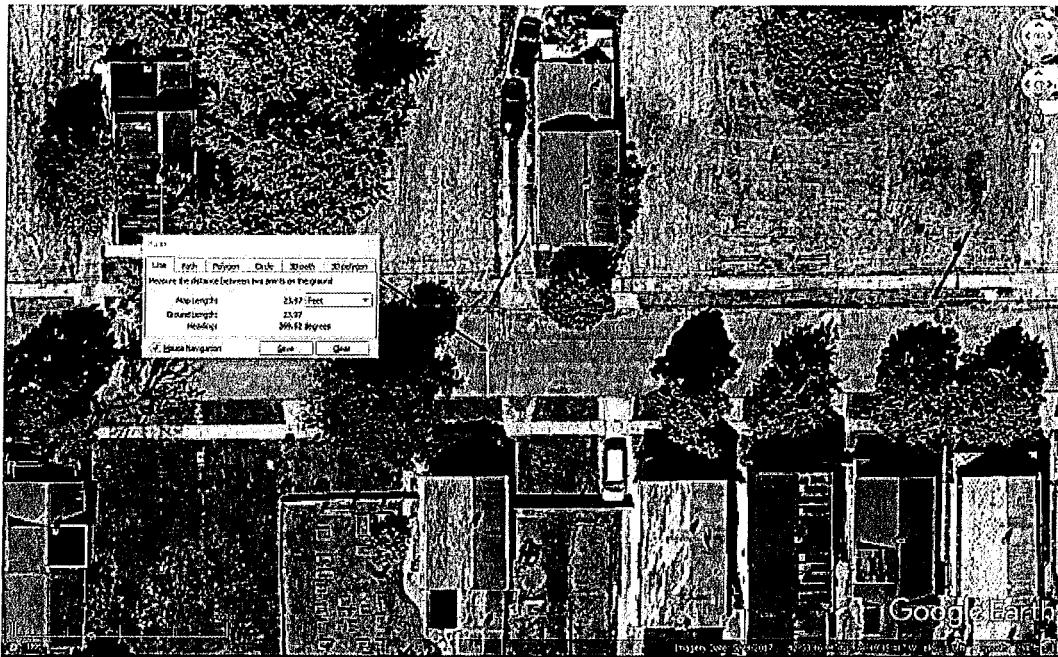
items visible in the provided security camera video footage. For example, using Google Earth Pro, the width of the roadway was measured to be 24 feet (Figure 2, top), distance from the north edge of the sidewalk near where the impact occurred (as viewed in the security video – sidewalk to the house just south of 37 Schmarbeck Avenue and perpendicular to the road) to the south edge of the 37 Schmarbeck Avenue driveway visible in the lower right corner of the camera 6 view (and also visible in camera 2 view) was measured to be 55.46 feet (Figure 2, middle), and the length of the sidewalk concrete slabs between joints (sidewalk parallel to the road) was measured to be 4.97 feet (Figure 2, bottom).

*Figure 2: Google Earth Pro image scaled measurements near 37 Schmarbeck Road relative to security cameras, photograph taken May 29, 2017*

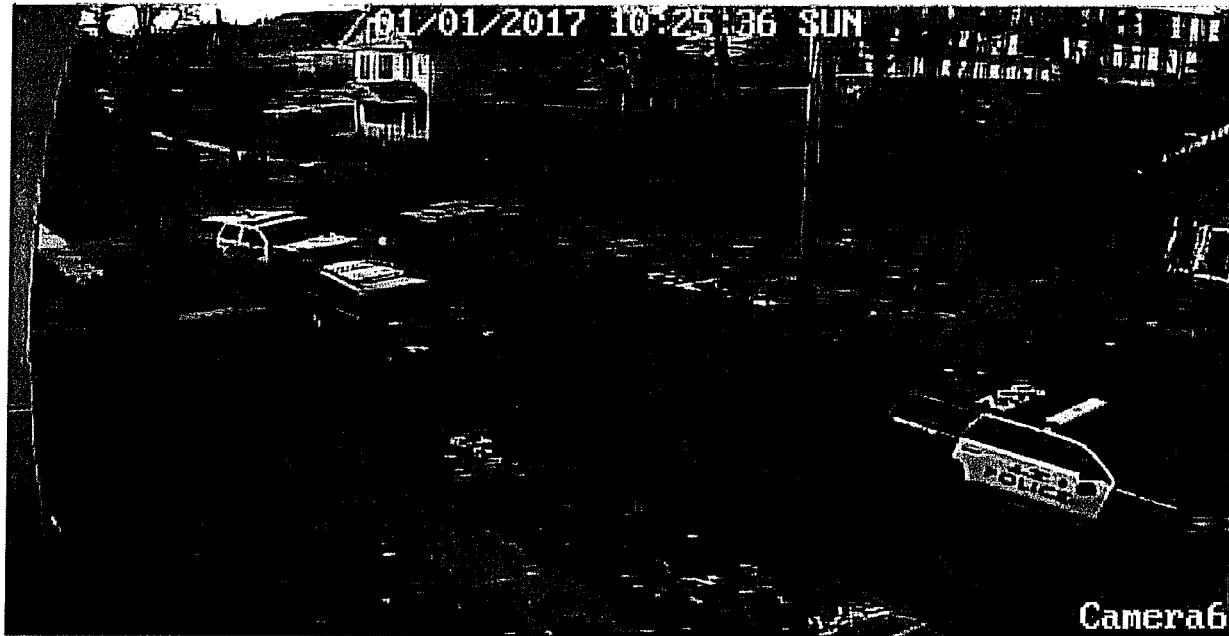
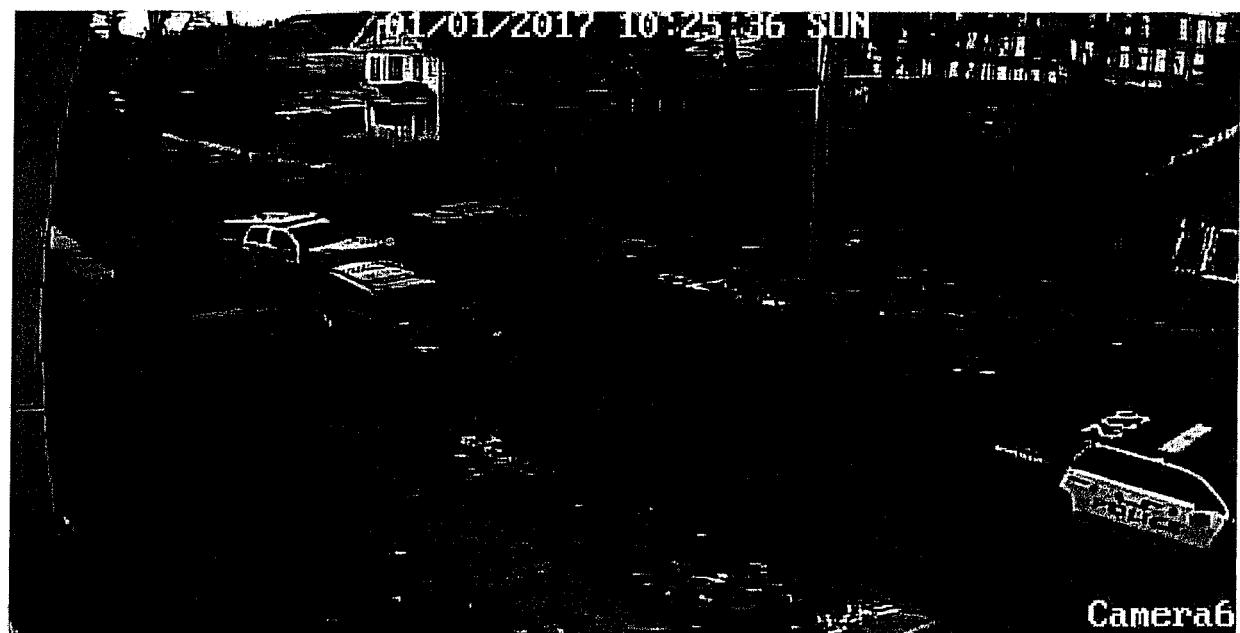
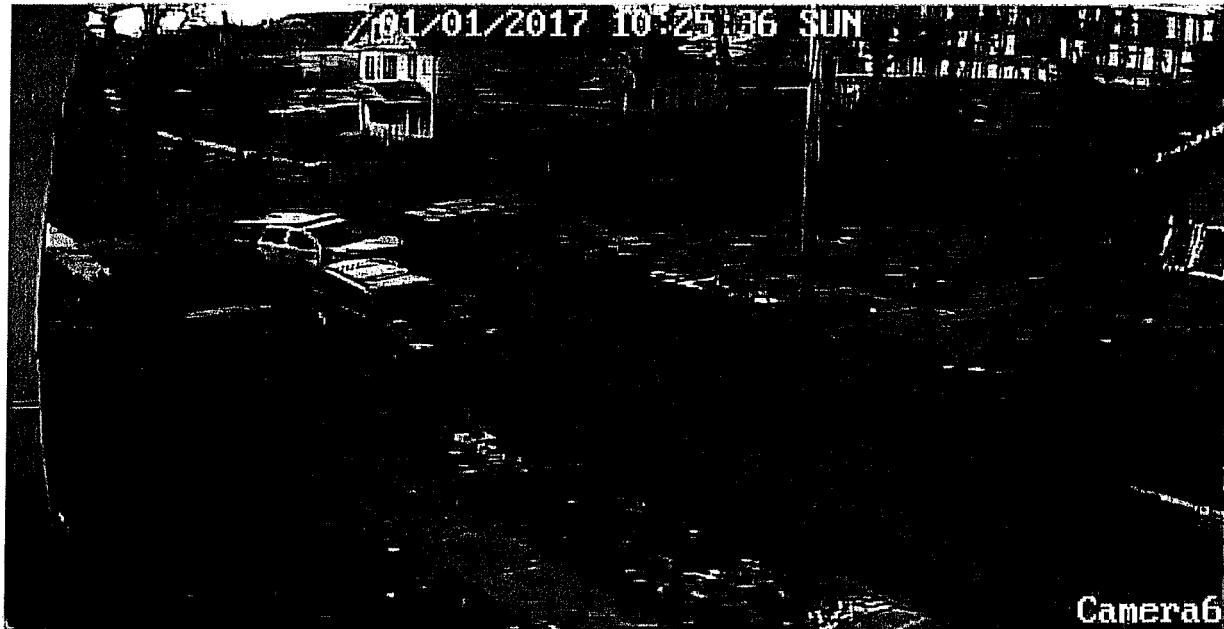
Based on this analysis, the impact between Mr. Kistner and the police vehicle Officer McDermott was driving occurred at approximately 10:25:36.667. It was determined that the police vehicle driven by Officer Moriarity began accelerating north on Schmarbeck Avenue at approximately 10:25:30 per the security camera time. The vehicle was positioned on the west side of the road as

*Figure 3: Distance tracking analysis showing the motion of Mr. Kistner and the two police vehicles frame by frame*

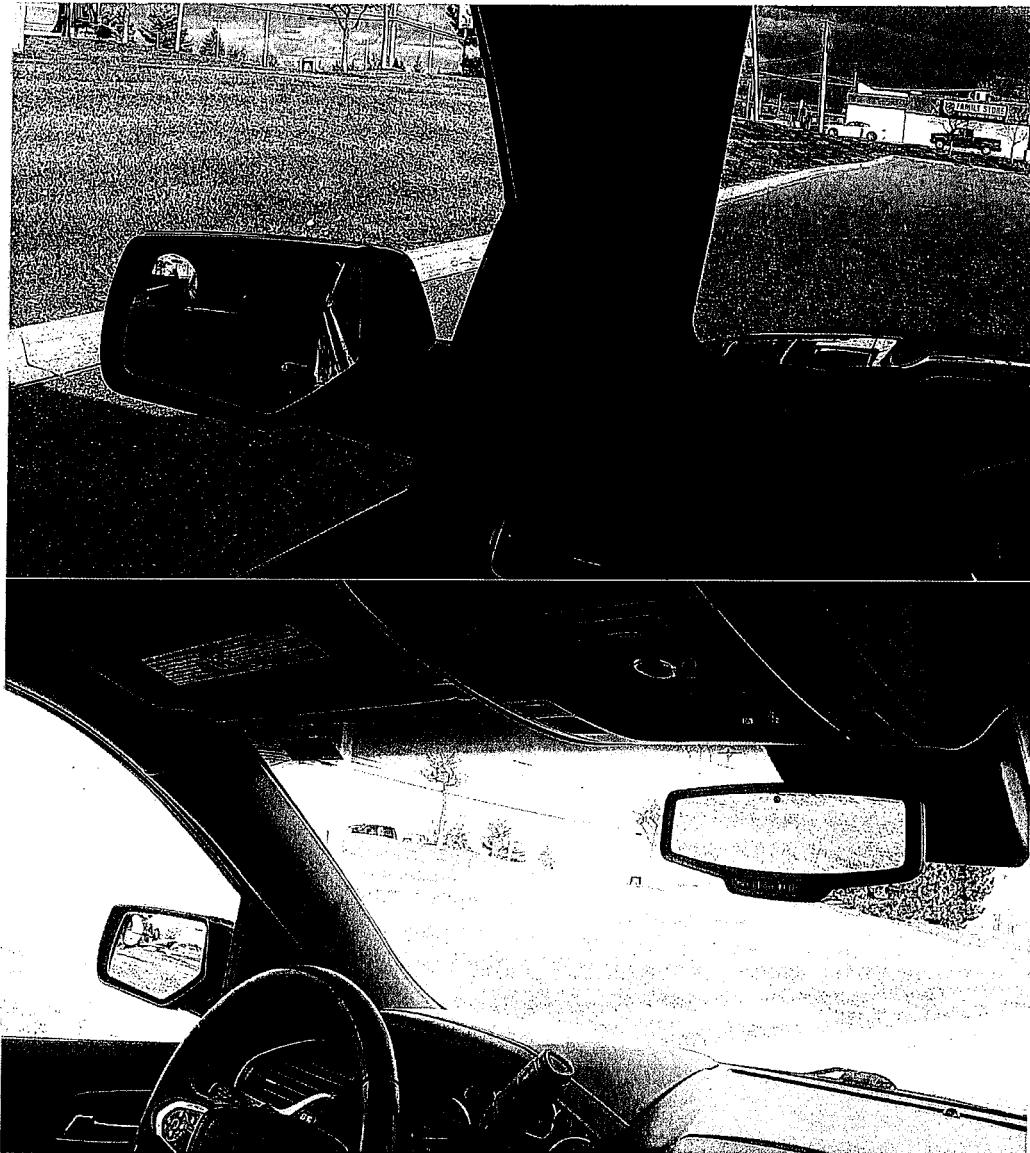
Figure 6: Exemplar Tahoe/Surrogate Side Mirror View Demonstration – Stationary Vehicle:  
driver view (top), passenger view (bottom)

Based on the demonstrations performed, at no time was the Kistner surrogate observed through the driver side mirror from the surrogate passenger's point of view. This view was strictly of the grass and roadway area located to the left of the vehicle, validating the Law of Reflection, and proving Officer Schultz did NOT in fact see the incident occur through the driver's side mirror as he testified.

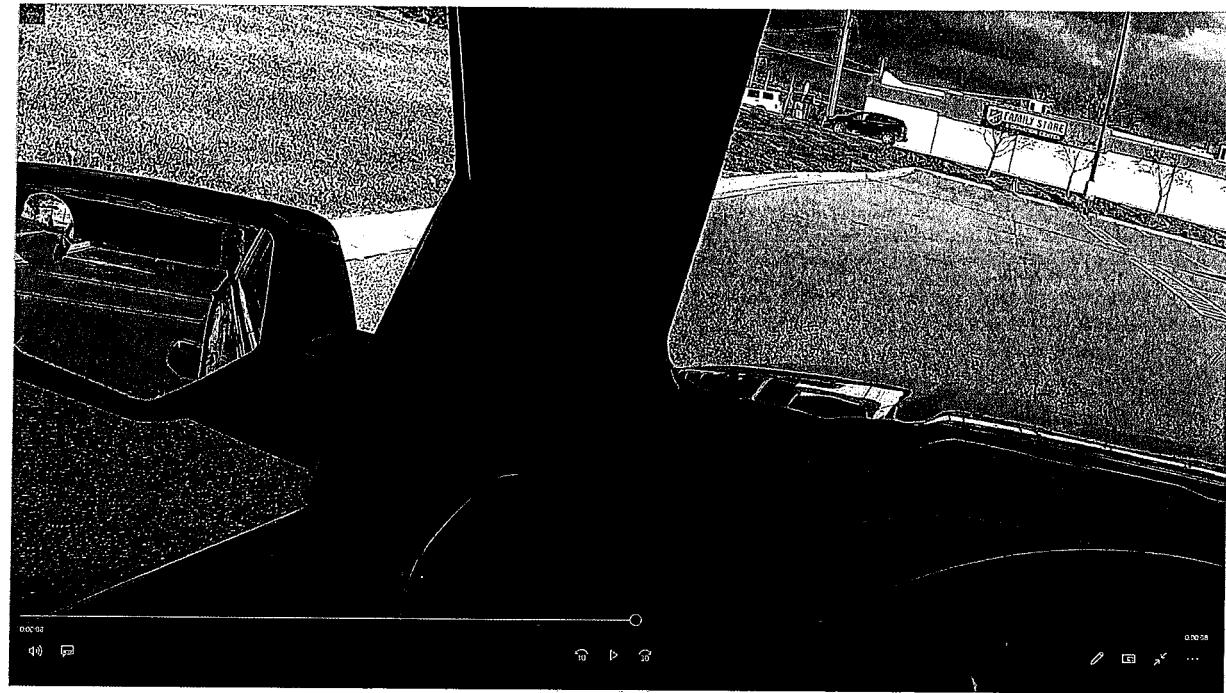
Figure 7: Exemplar Tahoe/Surrogate Side Mirror View Demonstration – Moving Vehicle: driver view

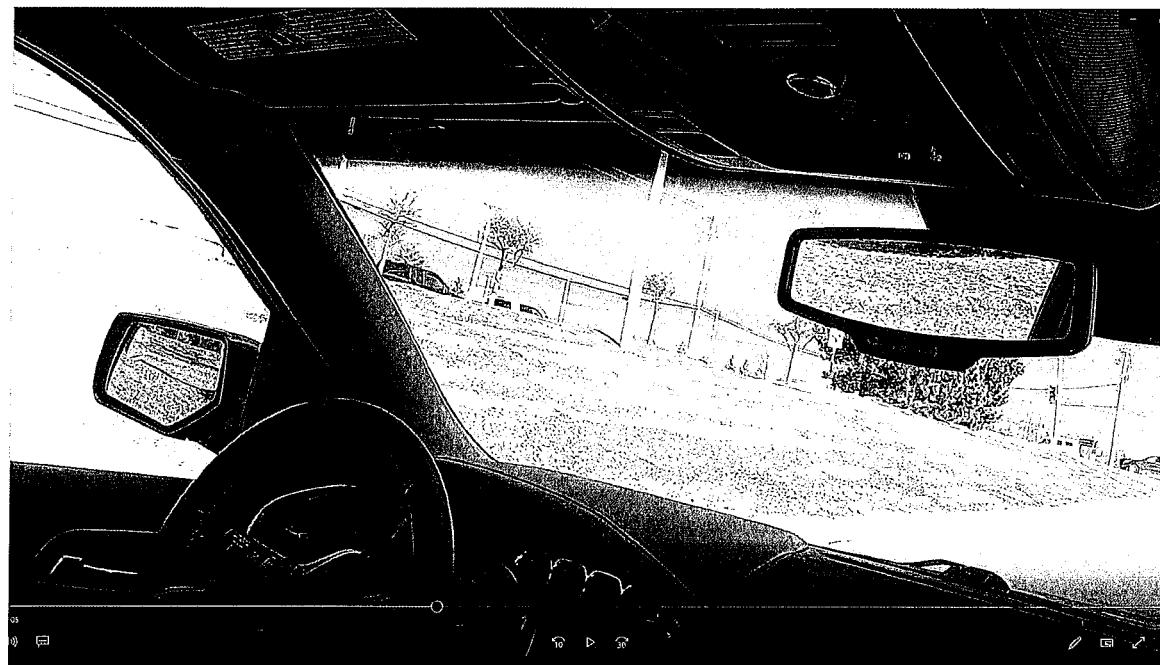
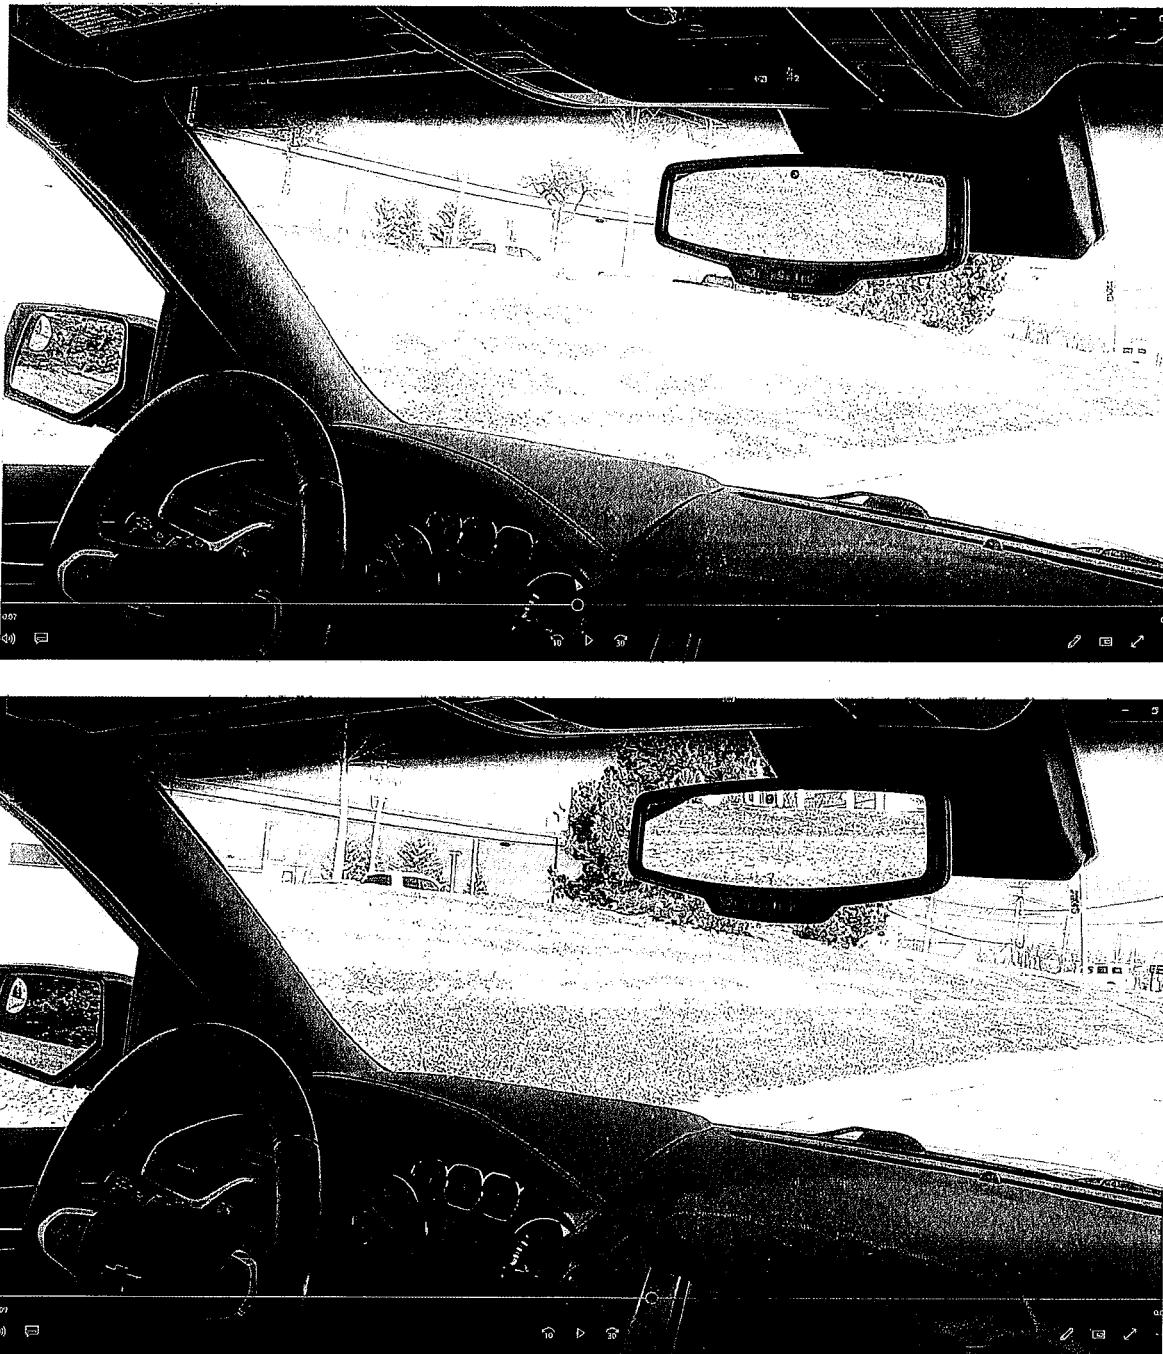
*Figure 8: Exemplar Tahoe/Surrogate Side Mirror View Demonstration – Moving Vehicle: right front passenger view*
